5.0 DAM RISK INVENTORY

Risk Profile by Piping and Conduit Failure Modes
El Paso Stormwater Master Plan

El Paso Stormwater Master Plan

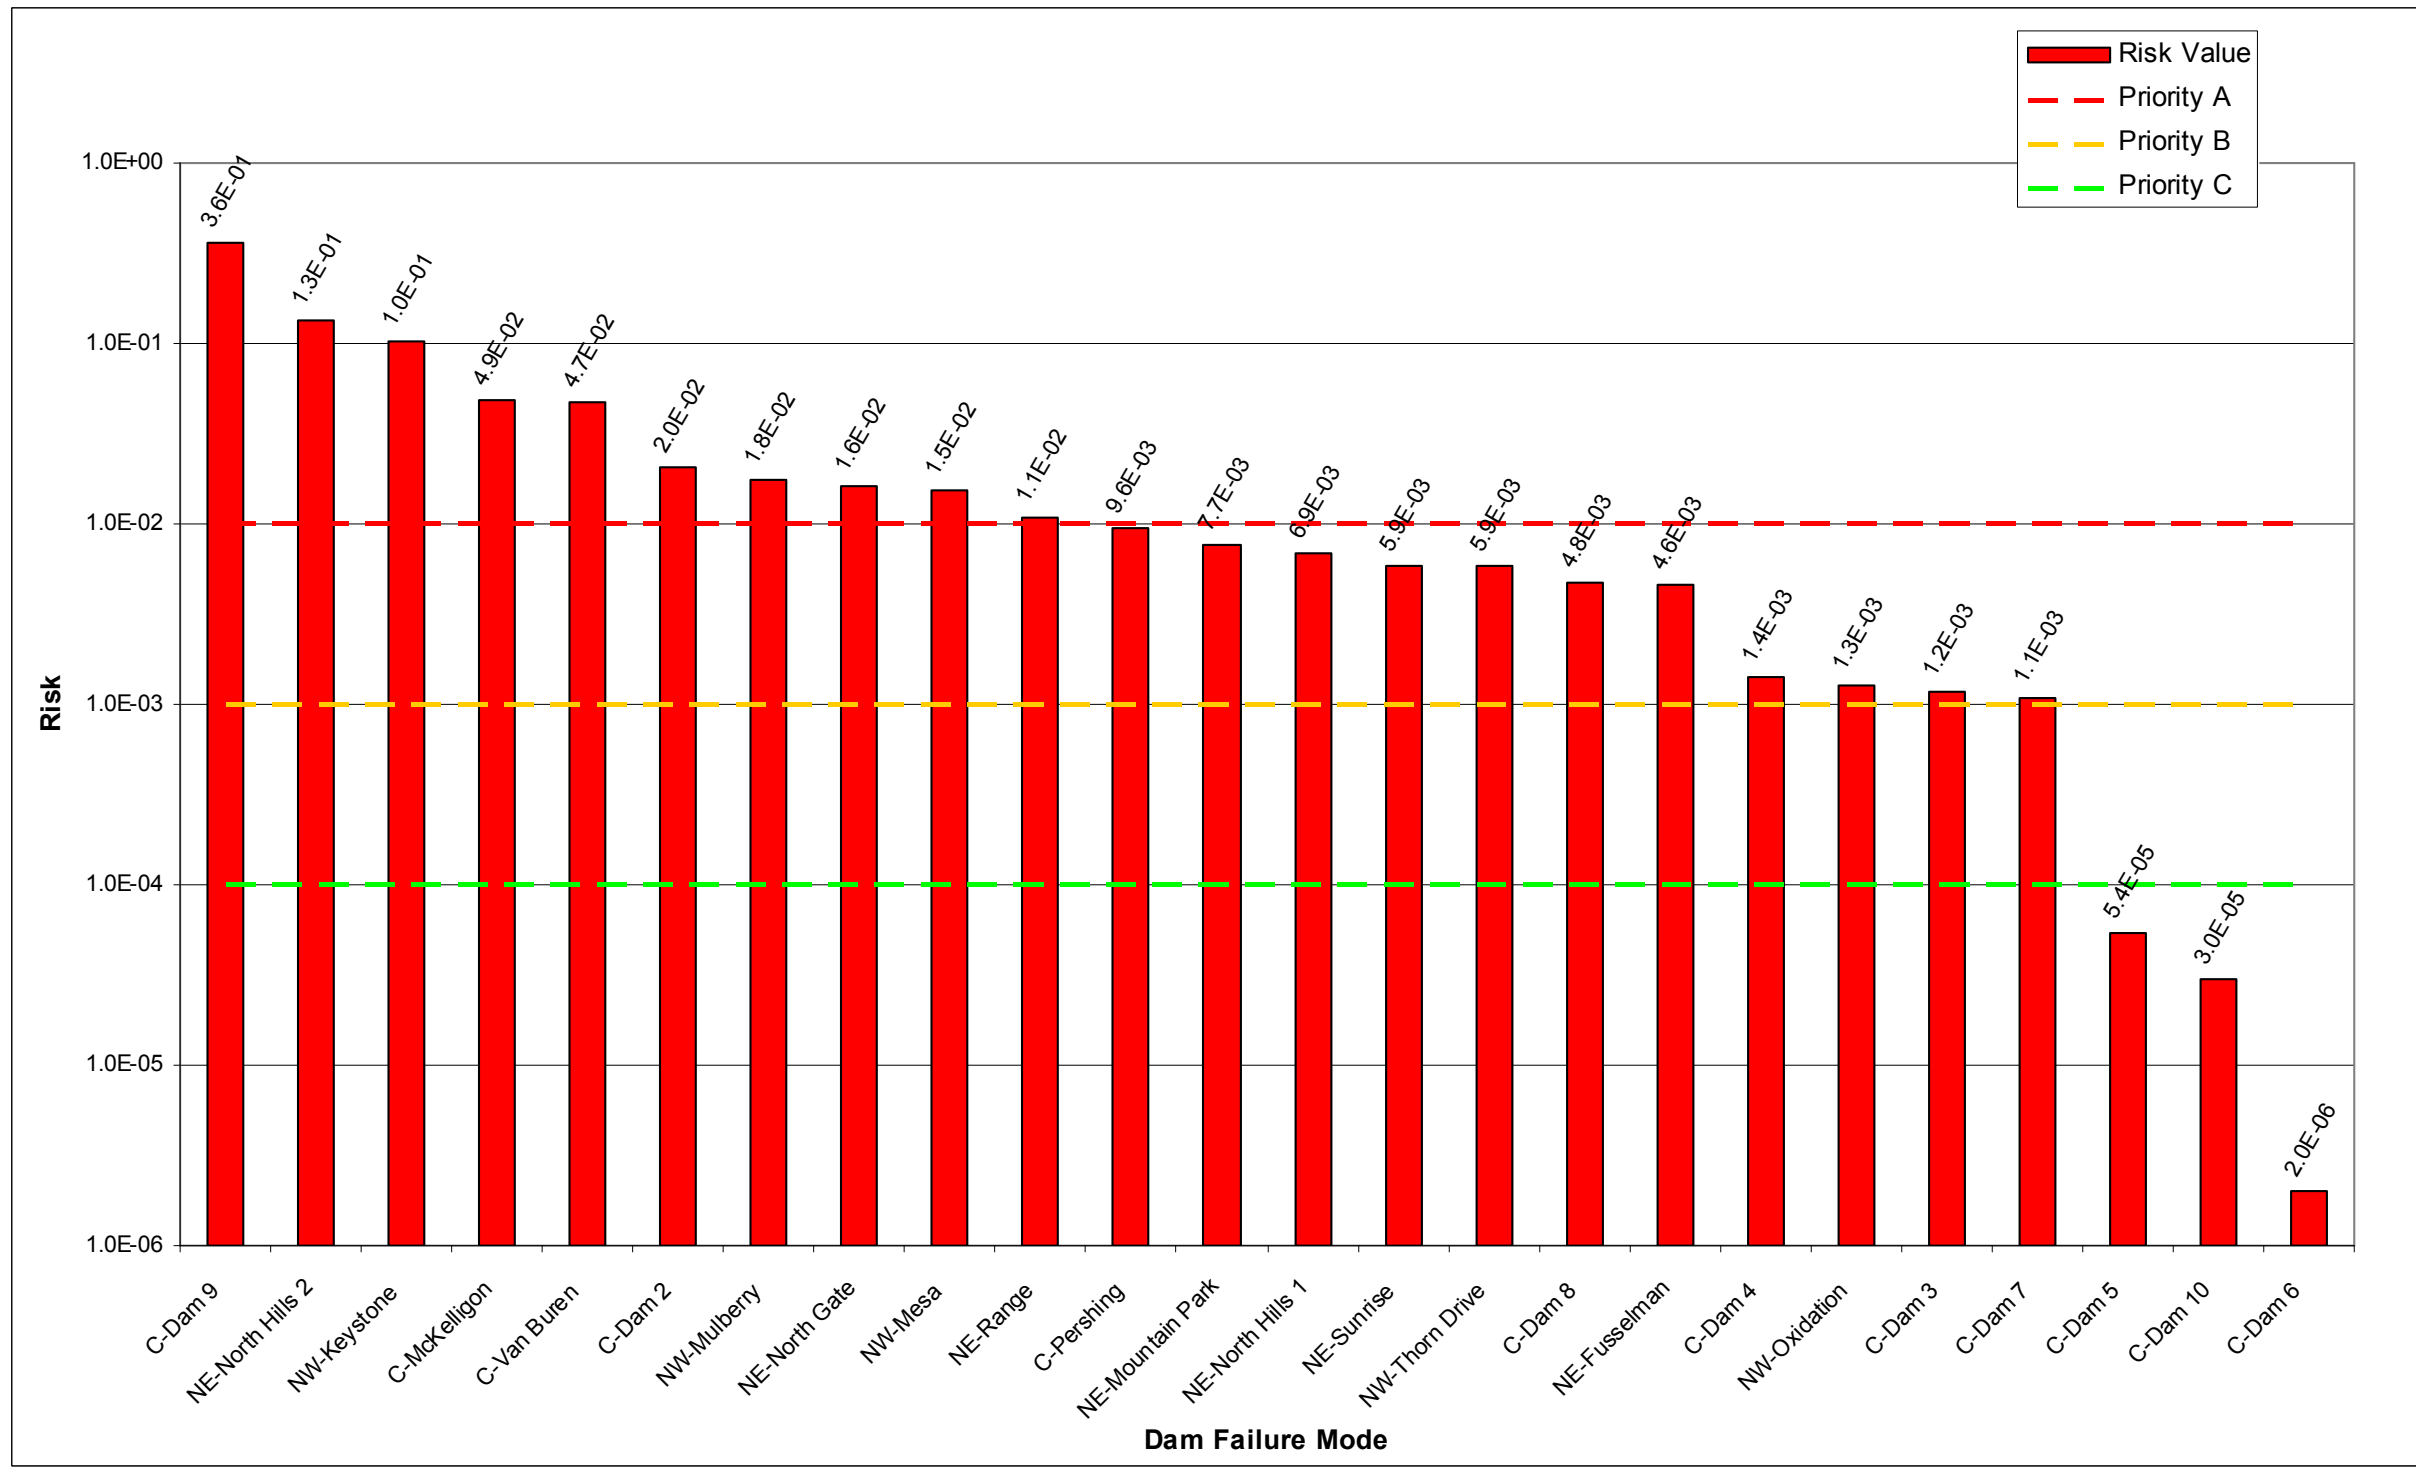
Date: 03/05/2009 Figure 5-1

Figure 5-1 shows the risk by piping and conduit failure modes and expresses the probability of failure of the 24 dams. According to Figure 5-1, analyzing only piping and conduit failure modes, 10 of the 24 El Paso dams receive Priority A classification. Of the remaining dams, 11 dams are Priority B, and 3 dams are below Priority C. An analysis of this risk demonstrates that the consequence of failure (e.g. lives at risk) rather than probability of failure drives the high risk ranking in almost all cases. In other words, the density of population downstream of the dam is so high that even a low risk of failure results in the failure mode receiving priority attention.

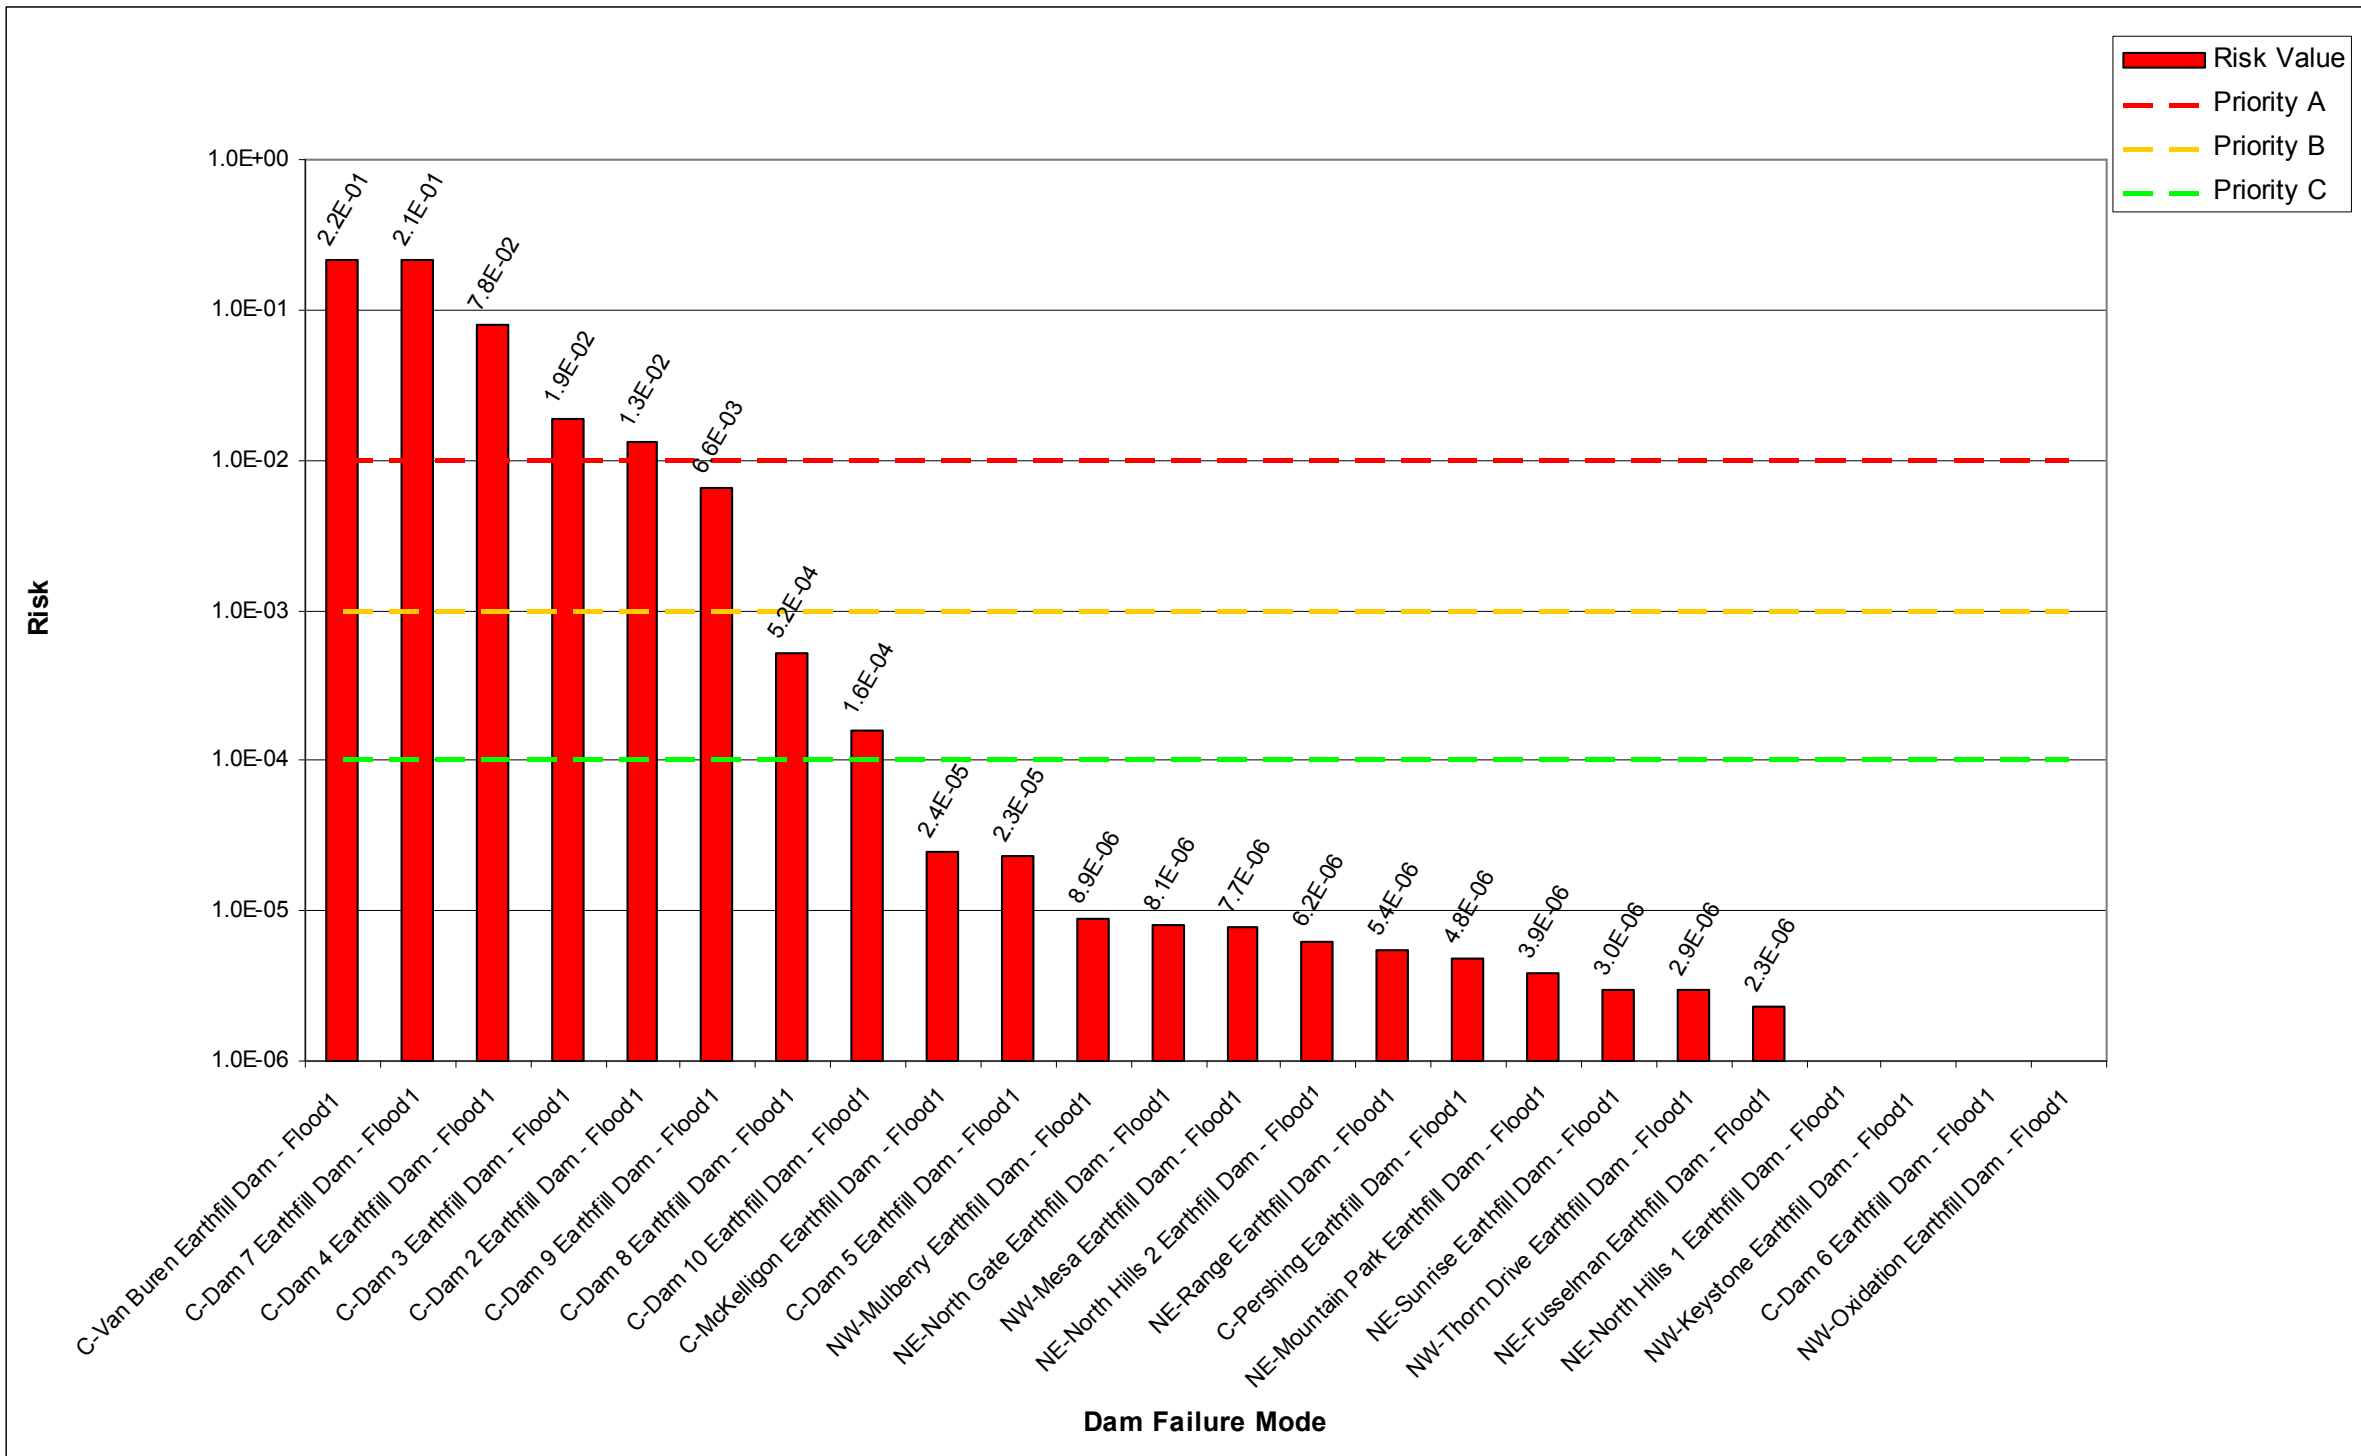
Figure 5-2 presents the results of the risk analysis for the overtopping flood failure mode. This analysis shows that when considering flood failure mode alone, only 5 of the 24 El Paso dams receive Priority A classification, 1 dam is Priority B, 2 dams are Priority C, and the remaining 12 dams are below Priority C. This clearly demonstrates that the risk of dam failure due to overtopping of the dam is not a major concern for the majority of the dams. The five Priority A dams for flood failure mode are Van Buren Dam, Dam 7, Dam 4, Dam 3, and Dam 2. The return period for the storms estimated to cause overtopping of these Priority A dams are each substantially less frequent than the 1,000-year flood; i.e. the risk of overtopping is substantially less than the risk of flooding associated with each project identified in Section 6.0. As with piping and conduit failure, a review of this analysis shows that the consequences rather than the probability of failure are the driving force behind the high-risk values. The elevated estimated risk of these dams is created by the large populations located immediately downstream. These dams are all in the Central Watershed.

Risk Profile by Flood Failure Mode
