On the Water Front

October 2016 | A Message from John Balliew, P.E., President/CEO

Accelerating Infrastructure Improvements for Reliability

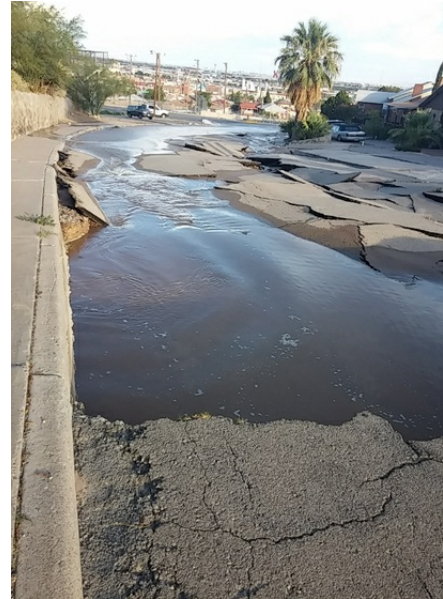
Ingersoll Way resembled a river in August when a water main ruptured. Rushing water damaged the asphalt and caused the street to collapse. The 62-year-old culprit was a cast-iron pipeline that is on a long list of needed replacements. It has broken eight times since 1968.

An Aug. 6 water main break destroyed portions of Ingersoll Way and Alabama Street.

Temporary repairs gave residents access to their driveways, and the water and sewer lines are now being replaced. The street will be repaved when the project is completed, bringing normalcy again to Ingersoll Way.

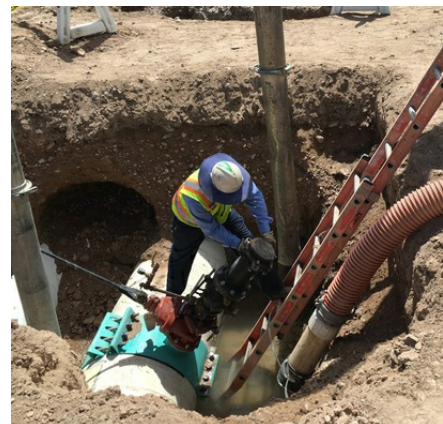
Even more troubling is a wastewater infrastructure failure, such as we experienced recently at Frontera and Doniphan. Our teams worked in difficult conditions to repair the system. It took weeks to reroute pipelines and upgrade valves and other components. For neighbors who detected an unusual odor, it was not a good time for a backyard barbecue to say the least.

A contractor's worker taps into the 42-inch Frontera Force Main to replace one of nine failed valves.
